# Manhole Inspection Summary

Manhole # S25GG2005MH

Insp Date: 11/15/06 1:46 PM

**Location** Address: **804 BELLEMORE RD**

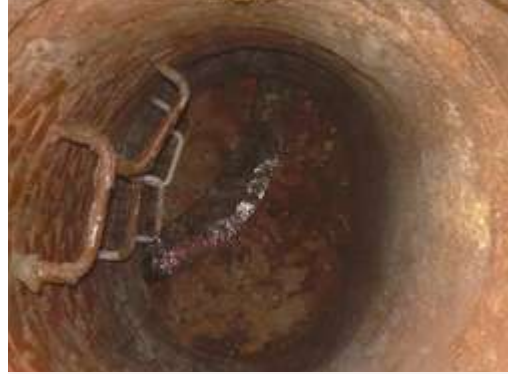
Top View

Corroded steps. Evidence of surcharge - Bench debris. Channel debris.

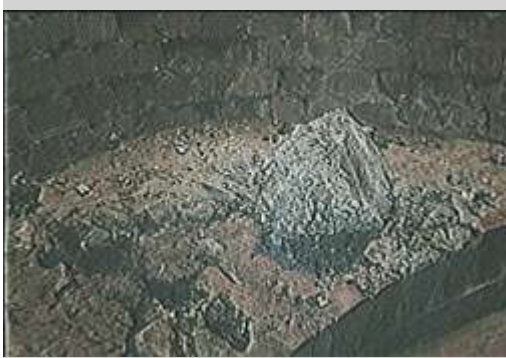
Defect

Barrel deterioration and infiltration. Bench debris.

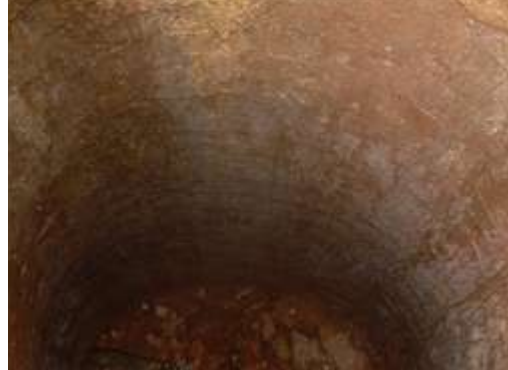
Defect

Adjustment and Barrel infiltration - other side.

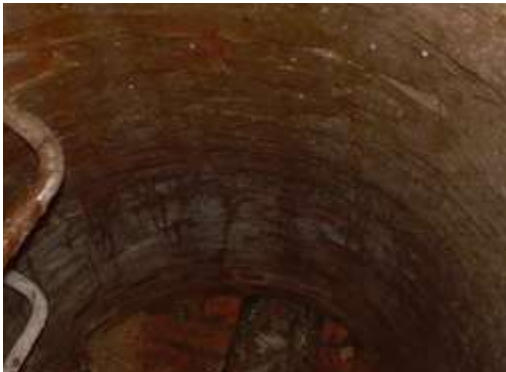
Defect

Adjustment and Barrel infiltration.

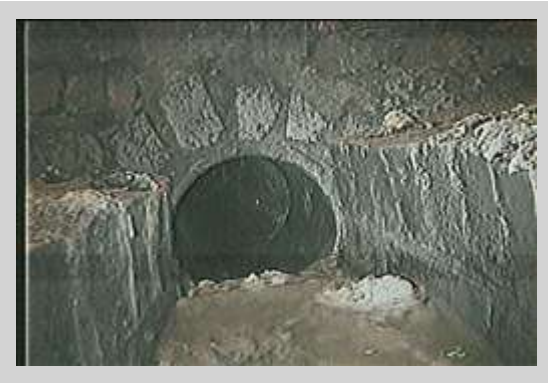
### 8 in. Circular Gravity Sewer Pipe Out @ 12 O'Clock

Channel debris.

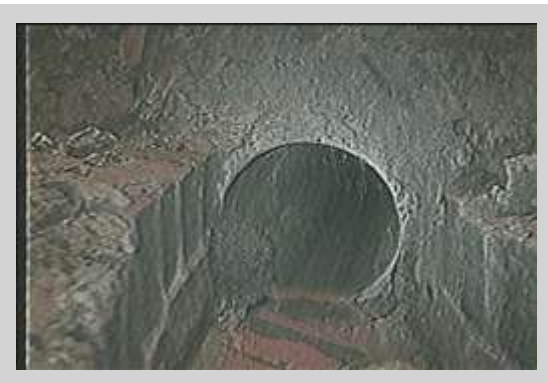
### 8 in. Circular Gravity Sewer Pipe In @ 8 O'Clock

Channel deterioration and root intrusion.
